DEPARTMENT OF TRANSPORTATION**DIVISION OF ENGINEERING SERVICES**

Quality Assurance and Source Inspection

Contract #: 04-0120F4Cty: SF/ALA Rte: 80 PM: 13.2/13.9File #: 1.28**WELDING INSPECTION REPORT****Resident Engineer:** Casey, William**Address:** 333 Burma Road**City:** Oakland, CA 94607**Report No:** WIR-026447**Date Inspected:** 03-Oct-2011**Project Name:** SAS Superstructure**OSM Arrival Time:** 700**Prime Contractor:** American Bridge/Fluor Enterprises, a JV**OSM Departure Time:** 1730**Contractor:** American Bridge/Fluor Enterprises, a JV**Location:** Job Site

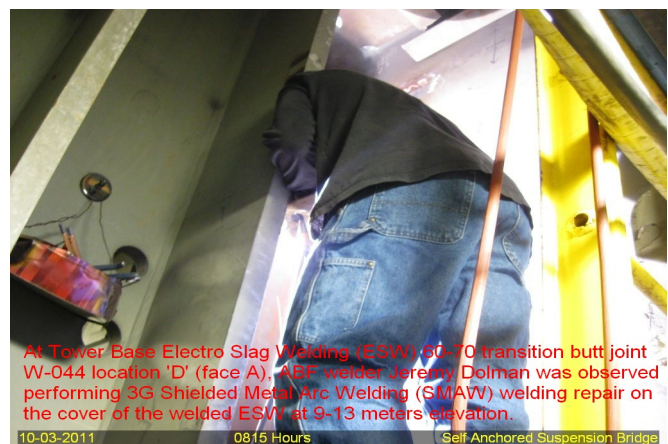
At Tower Base Elevation Electro Slag Welding (ESW) T-joint W-044 location 'D' (face A), QA randomly ABF welder Jeremy Dolman continuing to perform 3G SMAW cover welding repair due to excessive grinding on the visually noted overlap. The welder was observed welding in the 3G (vertical) position utilizing Shielded Metal Arc Welding (SMAW) with 1/8" diameter E7018H4R electrode implementing welding procedure ABF-WPS-D15-1000-Repair Rev. 2. The excavation was previously tested using Magnetic Particle Testing (MT) by ABF QC John Pagliero and randomly verified by this QA with positive result. The repair location and the

adjacent base metal were preheated to more than 300°F using the propylene gas torch. During the shift, ABF QC John Pagliero was noted monitoring the welder. Measured welding parameter during welding was 120 amperes on a 1/8" diameter E7018H4R electrode. Before the end of the shift, repair welding at elevation 9 to 13 meters location mentioned above was completed and the welder has moved to another ESW location 'E' (face B) wherein he excavated an Ultrasonic Testing (UT) detected defect of the welded ESW. The excavation was located at Y=800mm and was preheated to more than 250°F prior carbon arc gouging. Gouging on the excavation was still continuing at the end of the shift and should remain tomorrow.

1. S-045 location 'G' (face B) Deemed acceptable.
2. W-044 location 'D' (face A) Deemed acceptable.
